AG-AVT-140

Corrosion Fatigue and Environmentally Assisted Cracking in Aging Military Vehicles

Published March 2011

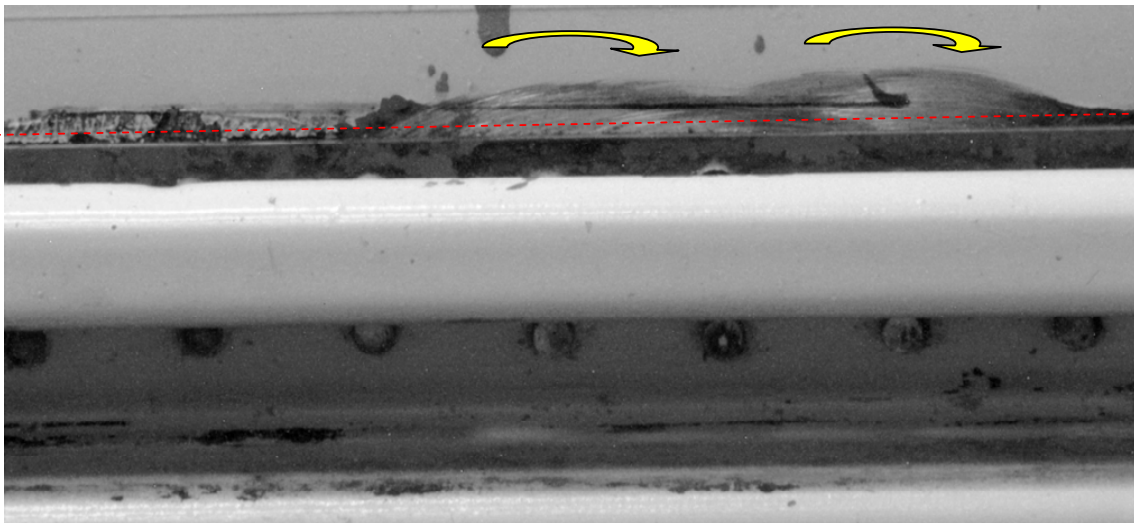
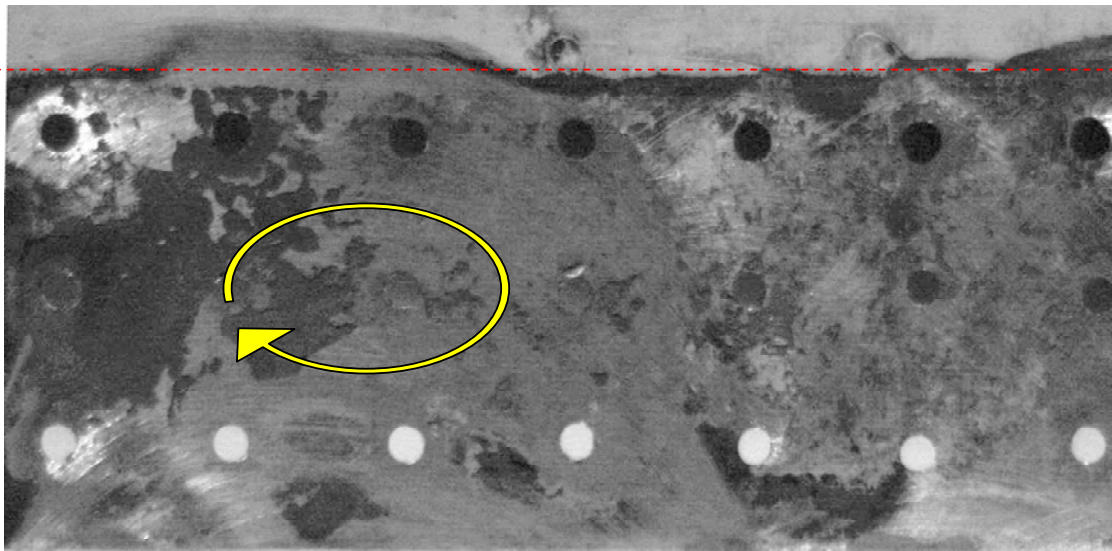
Evidence of the use of a rigid abrasive disc to remove faying surface corrosion is visible extending above the top edge of the inner skin on the inboard surface of the outer skin (red line) of the previously repaired and re-assembled joint shown in Figure 27-9(a).

(a) Rear surface of joint rebuilt after grinding for corrosion removal. Red line – Top of inner skin.

(b) First layer skin, inboard surface, disassembled, showing grinding marks. Red line denotes top of inner skin (removed).

Figure 27-9: Evidence of Grinding on Re-Assembled and Disassembled Joints.

Figure 27-9(b) shows the faying surface of the outer skin from the disassembled joint. The grinding marks indicate that the joint had been previously opened for corrosion removal, and that this was done using a motor driven rigid abrasive disc. The limited access and visibility mentioned above makes it understandable that motor driven discs of a diameter large enough to span the joint might be preferred to manual scraping/sanding tools. This is despite the fact that there are written warnings that powered grinding operations can generate temperatures sufficient to affect the temper of the aluminum. The only recommended powered corrosion removal tools are rotary files, flap brushes (both impractical in this instance) and *flexible* abrasive discs, see the FAA and Airbus guidelines after Figure 27-10. The point often missed here is ‘flexible’. The danger is the unintended damage done as a result of employing non-recommended tools and procedures owing to the difficult accessibility.

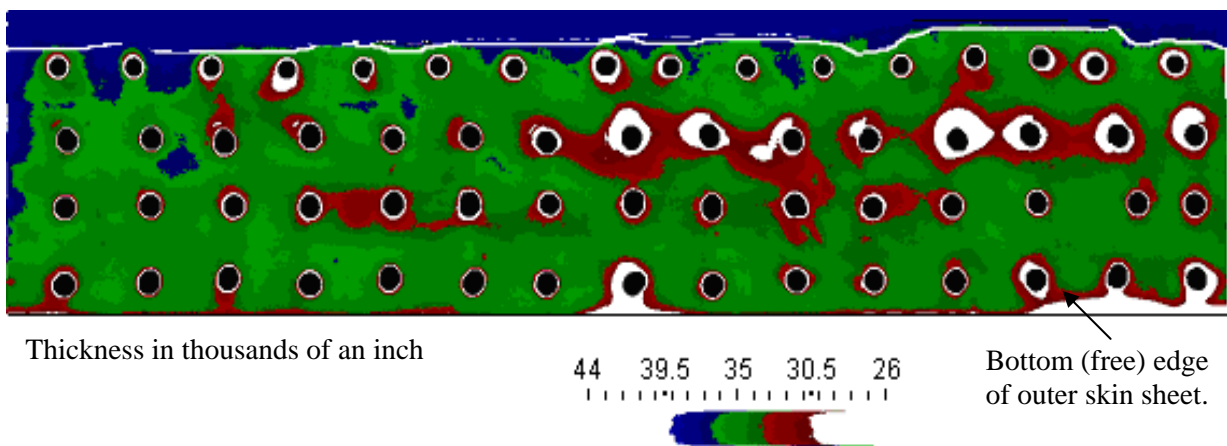
Figure 27-10: Digitized and Colorized X-Ray Thickness Loss Map for Outer Skin.

The selected removal technique, rigid abrasive disc grinding, resulted in significant skin thickness loss and produced knife-edges at fastener holes and at the free edge of the 0.038 inch (0.96 mm) thick sheet. These effects are illustrated by the digitized and false-colored X-ray thickness loss map shown in Figure 27-10: red indicates a range of 20 – 25% loss and white indicates a loss beyond the range of the calibration master. The minimum measured thickness was 0.026 inch (0.66 mm) at the bottom edge, a 34% loss.

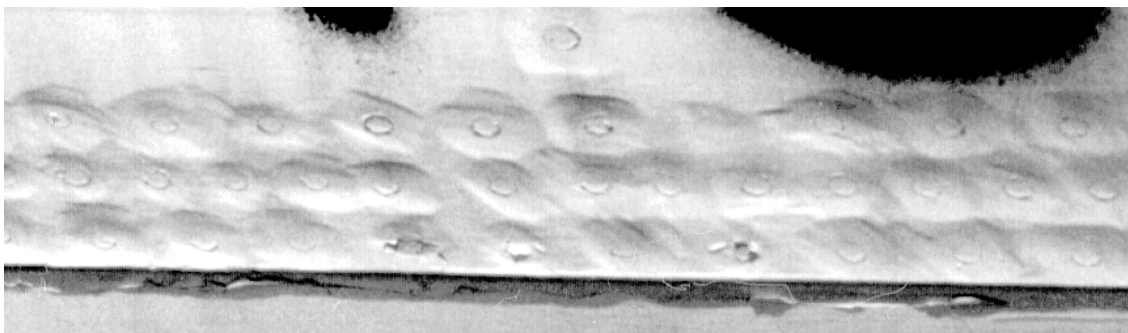
Exterior surface corrosion damage may be exacerbated when addressed with rigid abrasive tools and a lack of appreciation for the damage that can quickly be done. In the case illustrated in Figure 27-11 the effort to remove filiform corrosion damage around rivets succeeded only in grinding the heads off the rivets and thinning the adjacent skin, in some cases completely through the thickness. The minor damage and appearance issues were thus transformed into a completely ruined joint. As with the faying surface

corrosion removal situation, the outer surfaces are pillowed by the internal build up of corrosion products, and attempts to remove exterior surface damage must recognize the danger of removing sound material before the damaged area is cleaned up. Fortunately, this example was seen in an aircraft graveyard, but on the other hand the aircraft must have been flown to get it there.

Figure 27-11: Exterior Spot Grinding.

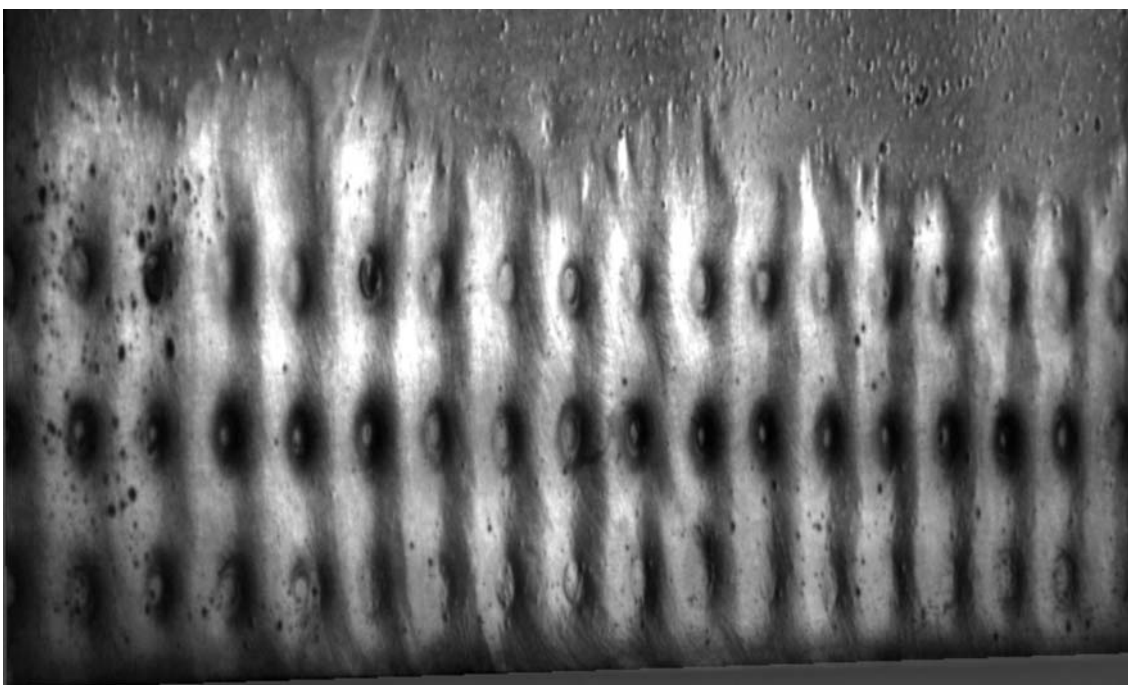
Figure 27-12 shows a DAIS view of another lap joint that was ground externally while also suffering faying surface corrosion with resulting pillowing. The pillowing complicated the grinding action and the DAIS image illustrates the damage and thickness loss to the skin. Not only was the skin thinned, but more importantly the heads of the rivets were also damaged, in this case most notably in the middle rivet row and as shown in a normal view in Figure 27-13. Clearly, either the grinding should be done after the rivets have been removed or the rivets should be replaced after the surface has been ground.

Figure 27-12: DAIS View of Pillowed Skin Suffering Surface Grinding.

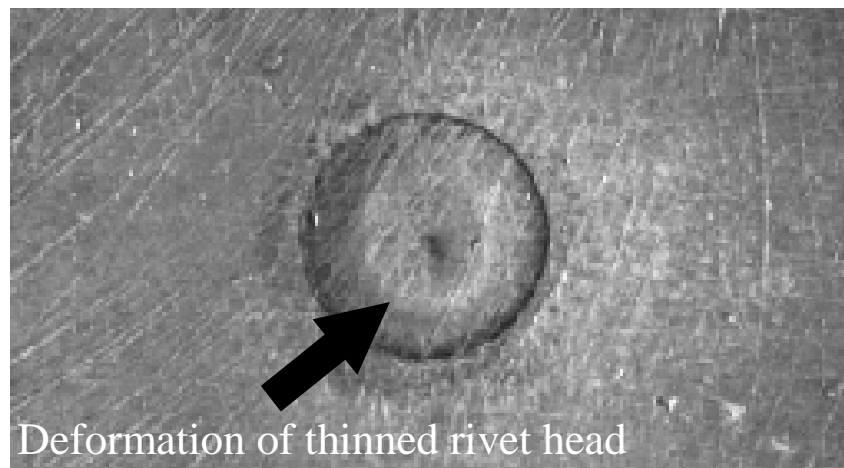
Figure 27-13: Close-Up of Grinding Damage to Rivet Head, Middle Row Rivet, Joint Shown in Figure 27-12.

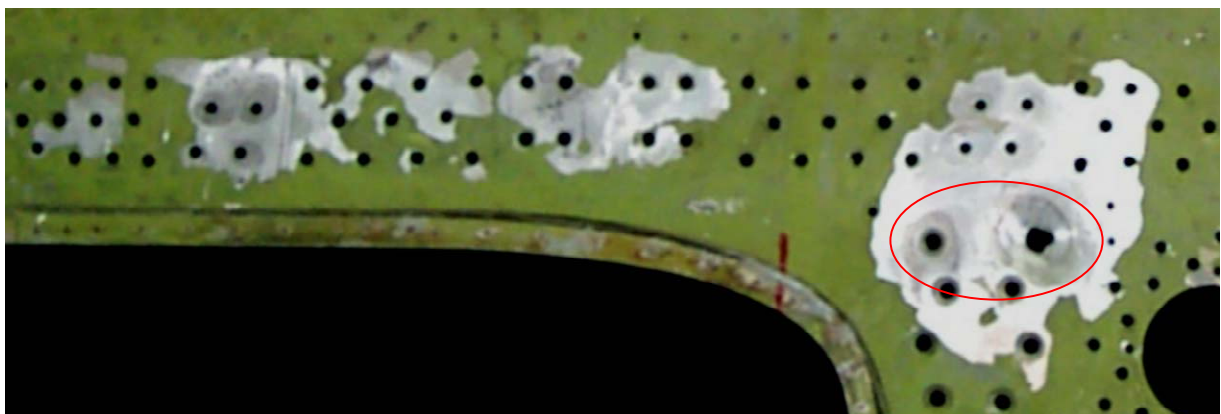
Figure 27-14 gives an example where severe exfoliation corrosion was removed from an upper wing skin plank. Unfortunately, the material removal and blending at two fastener holes (circled) went far beyond the allowed minimum thickness, and this resulted in the entire wing plank having to be replaced.

Figure 27-14: Upper Wing Skin with Exfoliation Corrosion Damage at Fastener Holes.

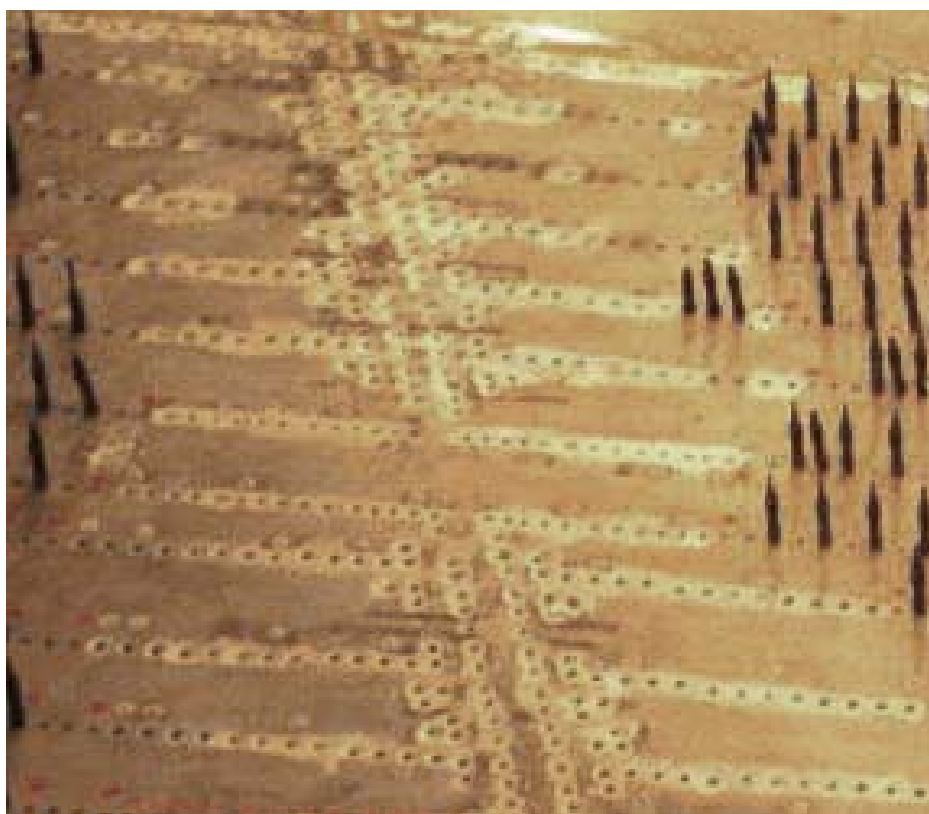
Another example is given in Figure 27-15. At great expense in time and effort almost every fastener site on the upper wing skin has been ground and blended-out to remove the exfoliation corrosion.

Figure 27-15: Upper Wing Skin with Multiple Sites Ground for Exfoliation Corrosion.

Testing [7] of upper wing skin material with similar levels of damage that has not been re-worked has shown that there is no decrease in load capacity or durability (compression-dominant fatigue). One might consider that more damage may be done to the structure by completely removing this form of corrosion; and that it would be better to surface grind to restore aerodynamic smoothness, followed by re-application of the protective coatings and institution of an NDI monitoring plan. This would probably be sufficient to extend the life of the part without the expense of extensive reworking.

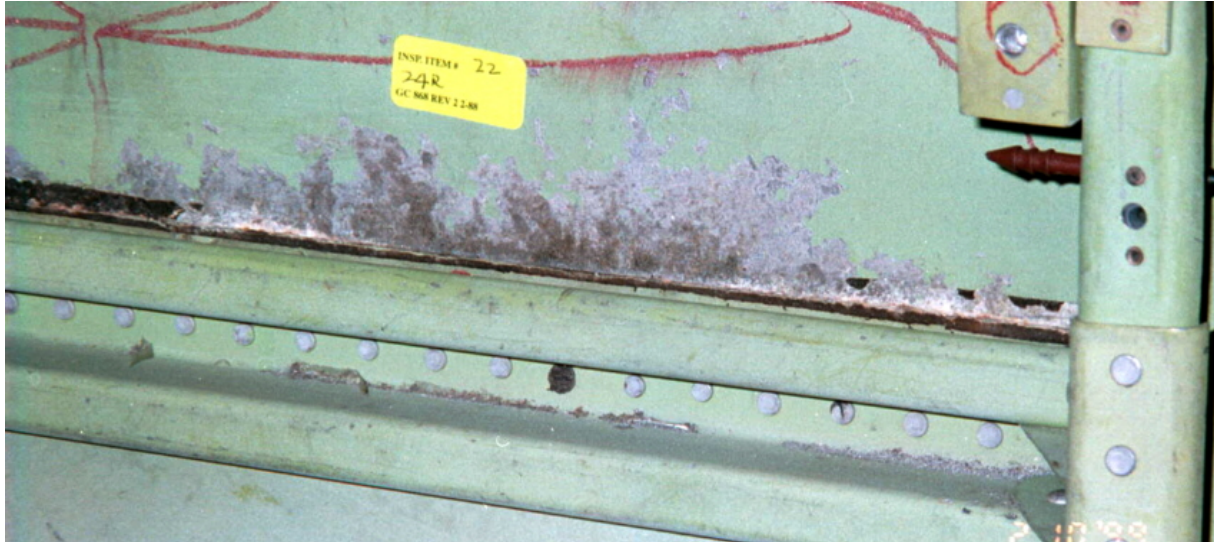
Figure 27-16 shows inside surface corrosion of an upper skin from a lap joint. This occurs more often and more severely than one might expect, for reasons given below.

Figure 27-16: View of Surface Corrosion on INBD Side of Upper Skin at Lap Joint.

On the outside of the fuselage the lapping of sheets top-over-bottom seems sensible if you are concerned with shedding rainfall. The exterior joint edge is given a bead of sealant to restrict moisture entry, and the integrity of that sealant is easy enough to check and replace. But what about the ‘rain’ inside? Internal moisture condenses, collects, and runs down the inside of the skin sheets until it hits the ledge formed by the top edge of the inner skin. This edge also receives a bead of sealant but it is only seen on rare occasions, like D Checks, and age plus pressure cycling eventually defeats these edge seals.

If lap joints were oriented the other way (as some lower lobe KC-135 joints are) the moisture running down the inside would not have a ledge to collect on; and if the lower edge of the inner skin is not caulked, then any breakdown in the outer sealant bead and /or faying surface sealant layer would naturally drain (until the easily accessible outer sealant breach is fixed). Alternatively, deleting the outer sealant bead on the lower edge of a standard lap would allow drainage of moisture that has entered the joint.

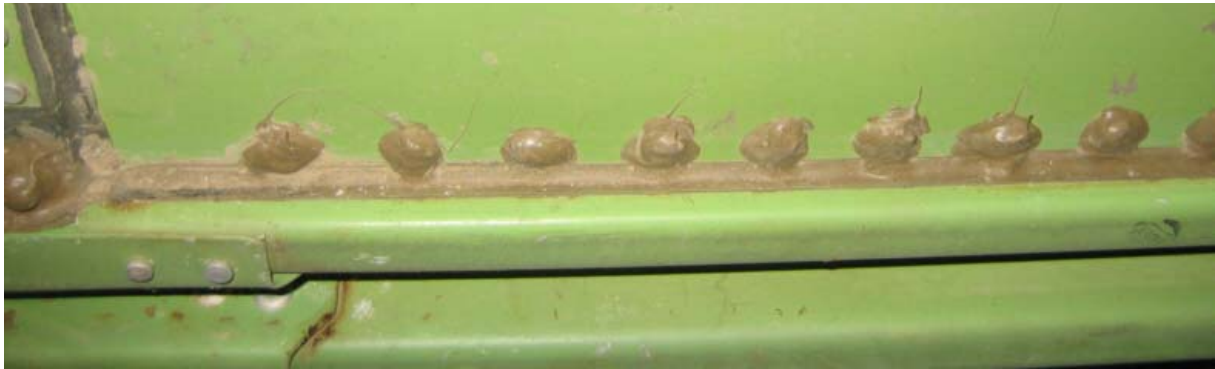
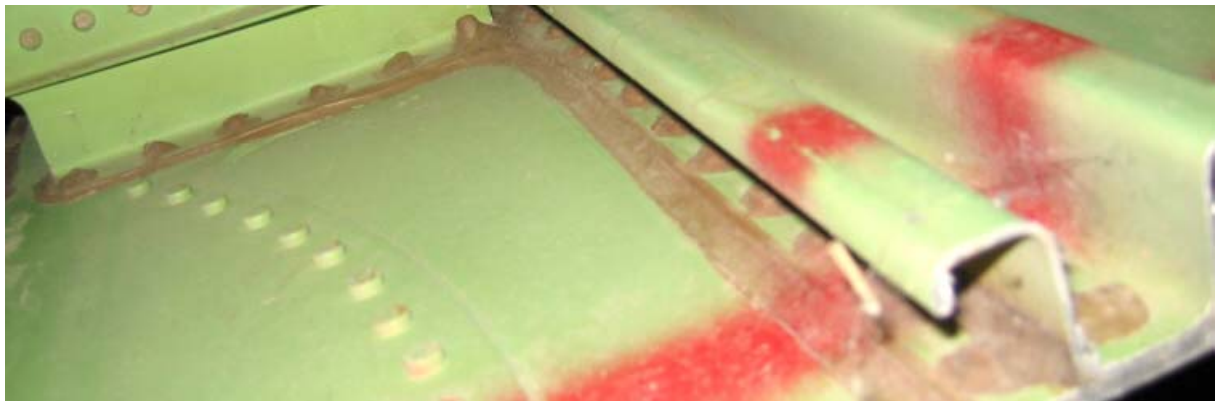
In response to the heightened awareness of how important corrosion can be for the integrity of ageing aircraft lap joints, some manufacturers mandated a comprehensive sealant program where every internal joint and fastener was potted or received additional sealant. Even the upper and lower edges of the stringer were sealed. This succeeded in only one thing: the moisture that was already in the joint was locked in, and inside corrosion was inevitable. Figure 27-17 is an example: sealants were comprehensively applied to exclude moisture intrusion in an attempt to avoid the development of crevice corrosion. The result was that every section harvested from the fuselage of this retired aircraft suffered corrosion inside the joints.

(a) Lap joint top row fasteners and stringer sealant application.

(b) View along lower surface of stringer on lap joint and body station frame attachment.

Figure 27-17: Rivet Shop Head and Stringer Edge Sealant Applications.

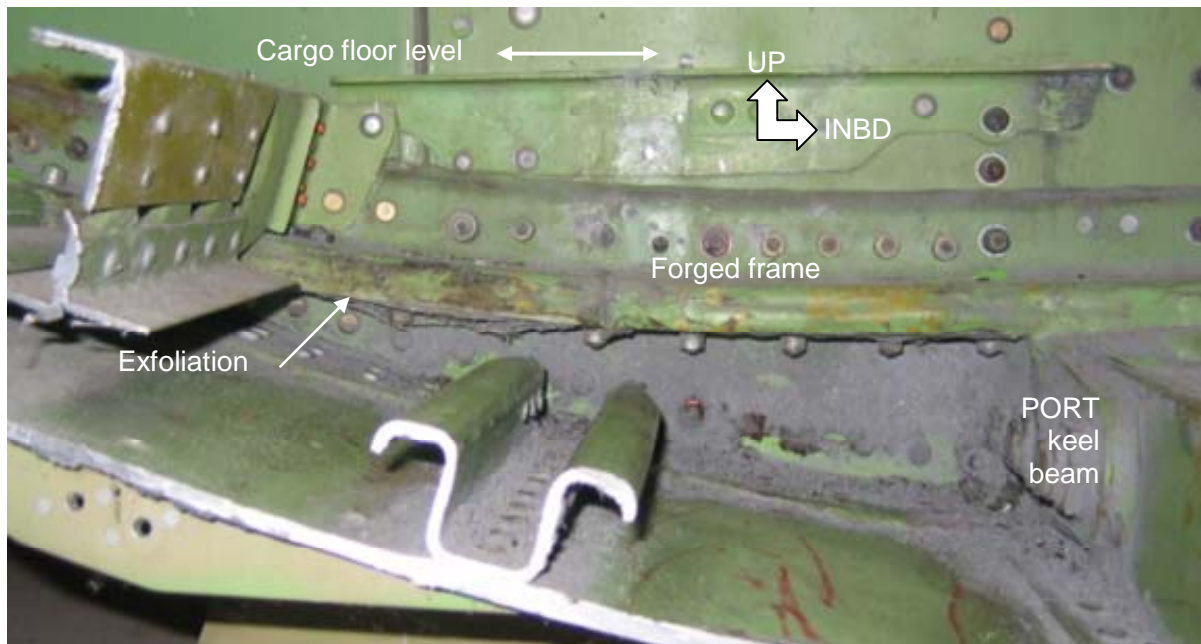
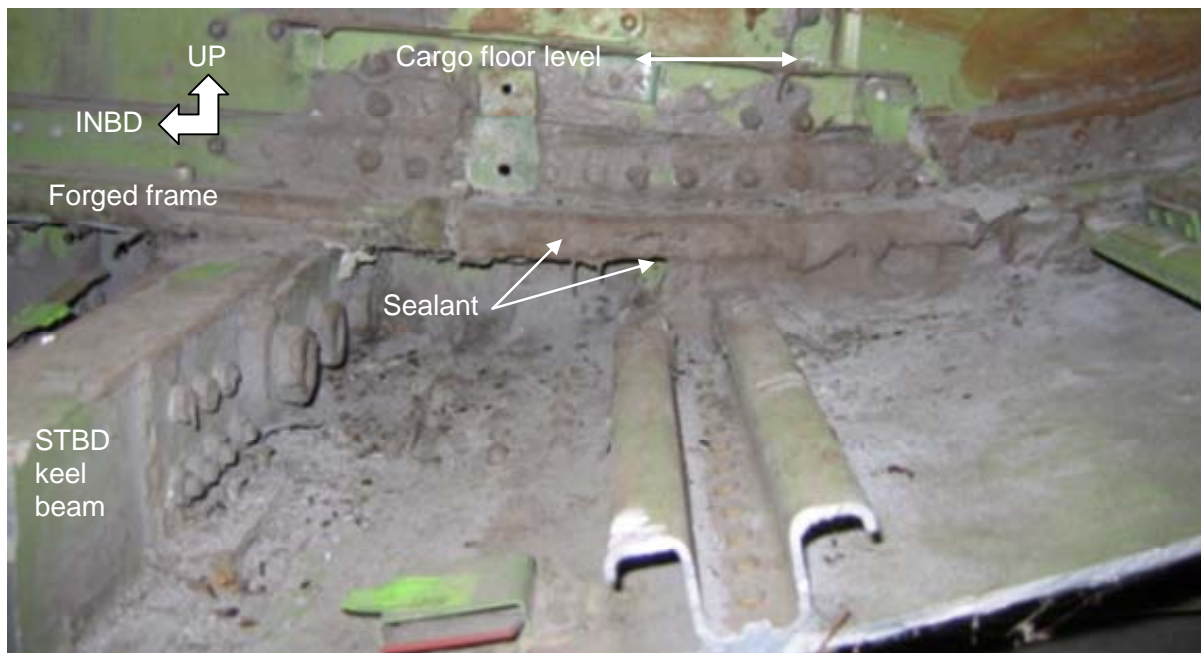
Figure 27-18(a) is a view of the port side of a bilge area in a fuselage where a heavy forged frame passes close to the bottom. The bottom surface of the frame has begun to exfoliate. This is a difficult location to inspect, since it is under the cargo floor and below the flange of the frame.

Figure 27-18(b) is the view of the starboard side of the frame. As may be inferred, exfoliation corrosion of the frame had been discovered previously, and following (any) remedial actions the frame was liberally covered with sealant. This prevented any later assessment of ongoing corrosion and the integrity of the frame. In fact, the area suffered significant further damage: large pieces of the frame could be pulled out from below, although the sealant was in good condition.

(a) View of area below cargo floor at fuselage frame, PORT.

(b) View of area below cargo floor at fuselage frame, STBD.

Figure 27-18: Views of Exfoliated Frame Treated with Sealant.

Maintenance procedures for corrosion damage removal end with the requirement that surface protective coatings be re-applied to the cleaned area (wash primer, primer and possibly paint). There is no mention of encasing the area in sealant. Besides the problems illustrated in Figure 27-16 – Figure 27-18, the sealant would also act as a barrier thus preventing any benefit from CPC applications.

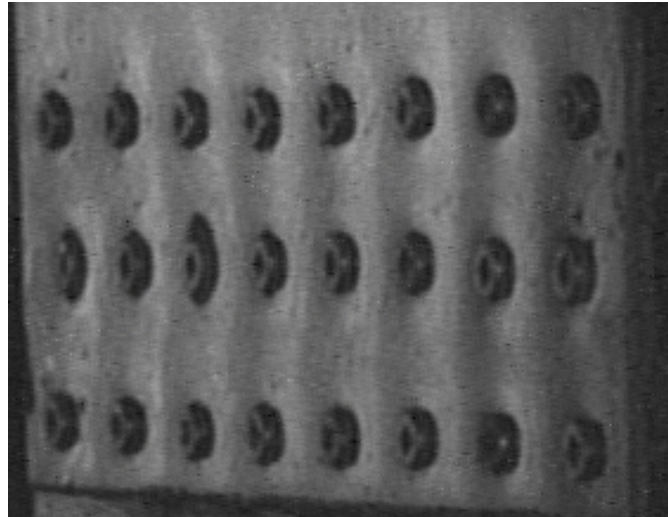
On the other hand, a sealant layer is required to be between the inner and outer fuselage skins in order to prevent fretting and achieve pressurization requirements. Care must be taken in applying a thin even layer (recommended 0.02 inch (0.5 mm) thick) otherwise the joined sheets may be deformed by any excess sealant, see Figure 27-19 and Figure 27-20. This deformation will confuse subsequent exterior visual inspections for corrosion pillowing unless the repairs are documented and subsequently referred to before re-inspection.

Figure 27-19: Surface Deformations from Excess Sealant in Laboratory Test Lap Joint (Non-Aerospace Fasteners).

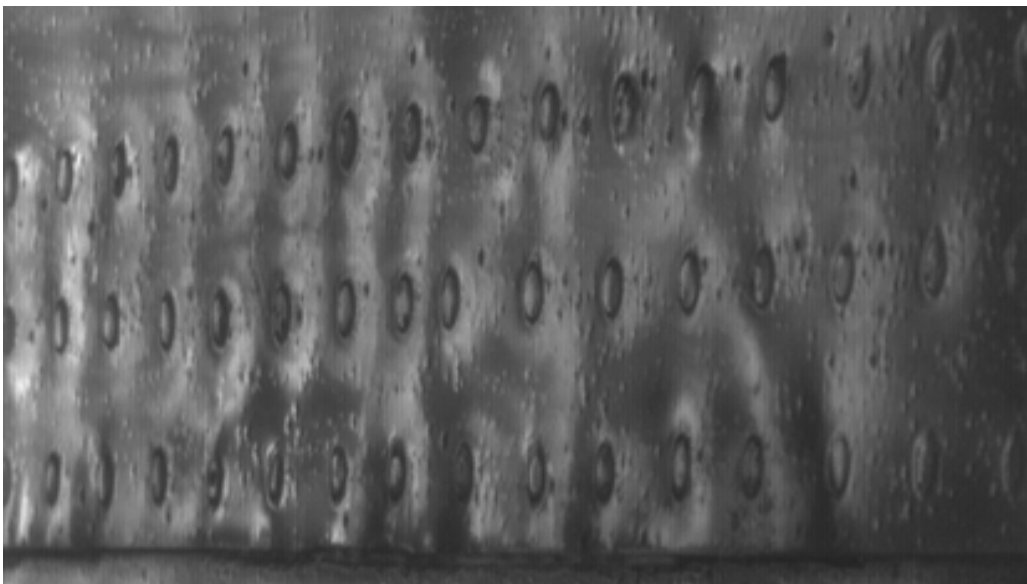
Figure 27-20: Surface Deformations from Excess Sealant in Repaired On-Aircraft Lap Joint.

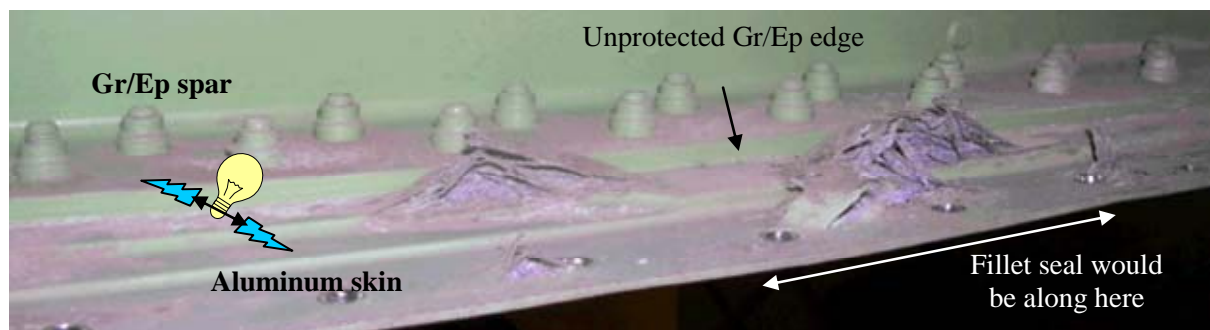
The Graphite Epoxy (Gr/Ep) framed / aluminum skinned structure shown in Figure 27-21 had the standard glass fiber insulating layer for galvanic corrosion protection. There was also a fillet seal to prevent moisture entering from the outside. However, internal corrosion took place, basically because the edge of the Gr/Ep spar was not sealed, i.e., the glass fiber layer was not wrapped around the trimmed Gr/Ep edge. The corrosion mechanism is as follows: although there was no direct contact between the graphite and aluminum, moisture accumulated internally and bridged between the ends of the graphite fibers and any scratches through the protective coatings on the aluminum skin, thereby completing the electrical circuit.

Figure 27-21: Graphite to Aluminum Connection Produces Corrosion.

- Any graphite fiber patch repairs on metallic surfaces would have to be similarly insulated and edge sealed to prevent similar occurrences of corrosion; and
- Routine inspections would have to include condition assessments of these features of the repairs.

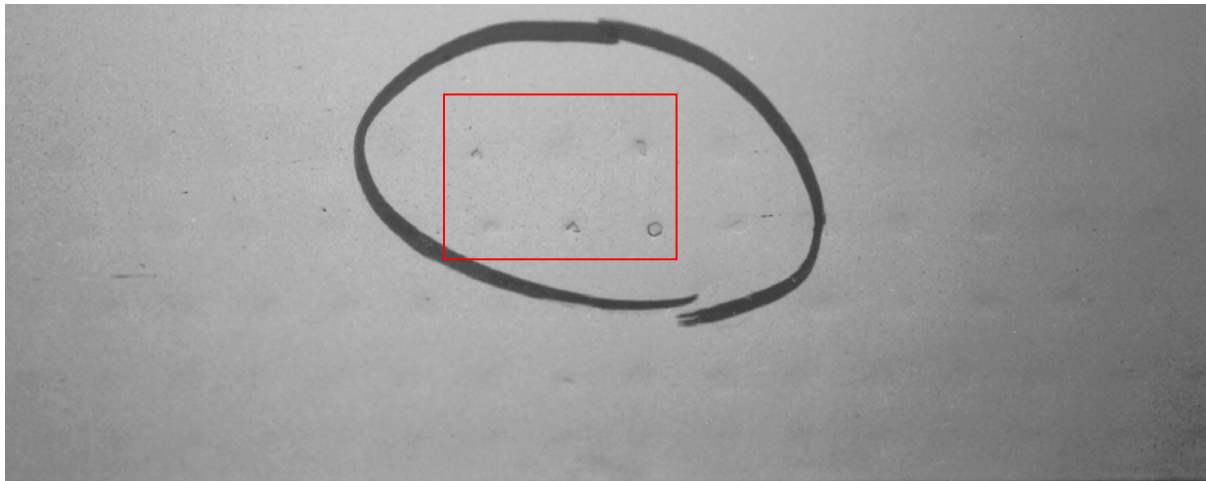
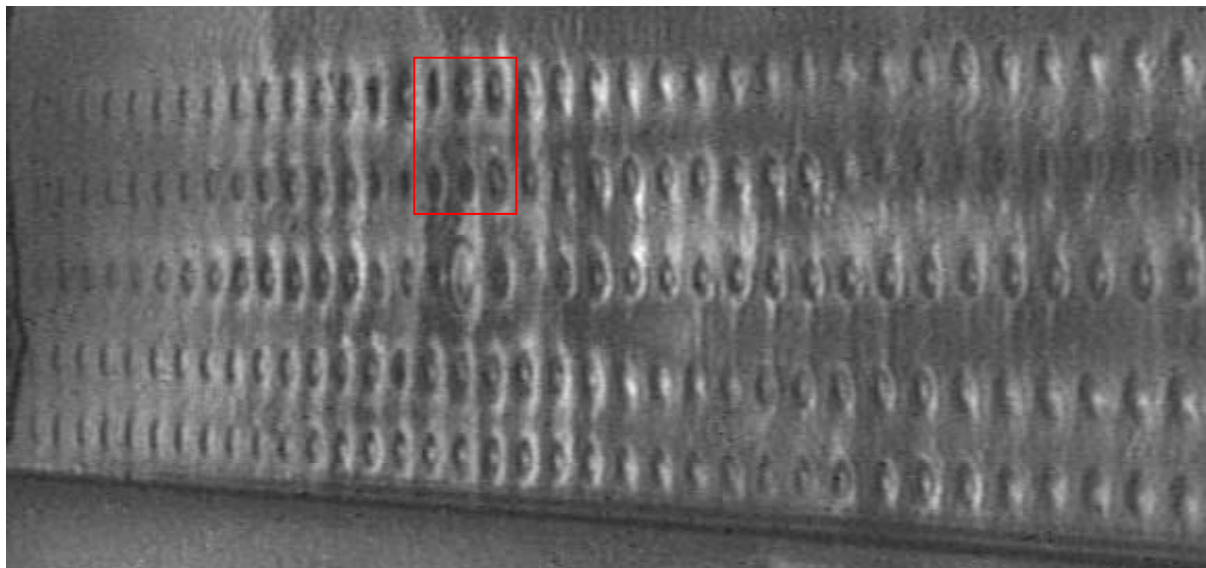
In corrosion situations spot-welded structures fail differently to riveted ones. Owing to pillowing forces, cracks occur in the spot welds and grow towards the surface. The corroded and cracked areas may not be easily visible, even with enhanced techniques such as DAIS, Figure 27-23(b), until the cracks have reached the surface and gone on to crack the paint, see Figure 27-23(a). Dye penetrant or magnetic particle inspections are required to detect the surface-breaking cracks in their early stages. Besides corrosion clean-up, if feasible and necessary, repairs are made by drilling out the cracked spot welds and installing rivets.

(a) Normal view. Cracked paint aids visual detection.

(b) DAIS view shows only subtle difference between normal deformation and corrosion pilling.

Figure 27-23: Corroded KC-135 Spot Welded Lap Joint with 4 Fractured Welds (Inside Red Boxes).

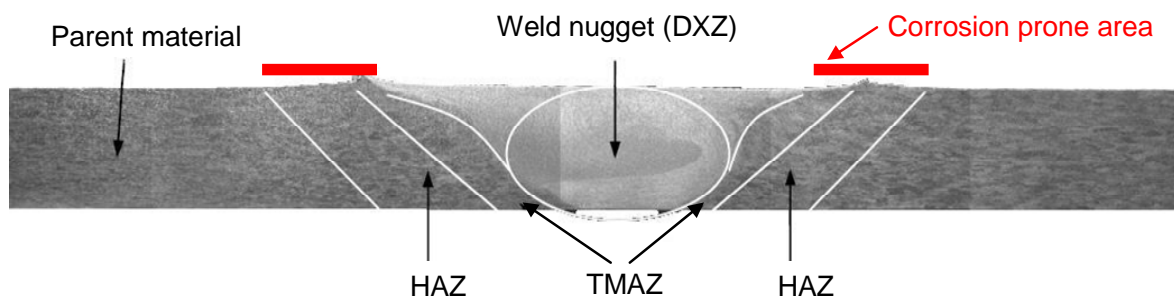
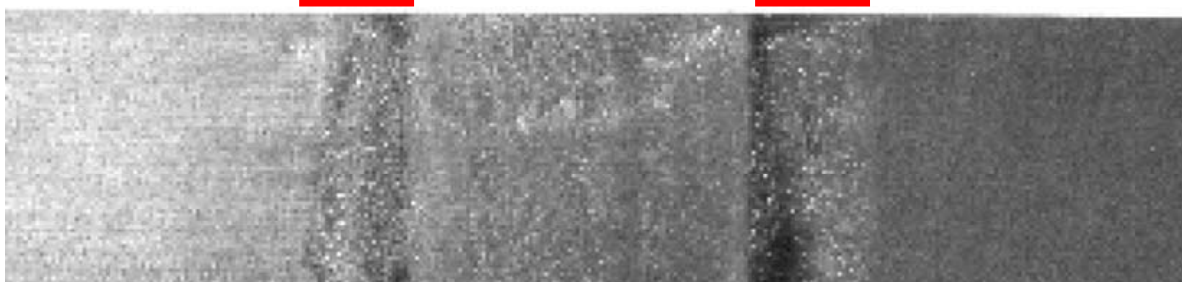
Figure 27-25: FSW Joint Structure and Corrosion Damage.

A friction-stir weld is typically characterized as being comprised of three primary zones: the Heat-Affected Zone (HAZ), the Thermomechanically Affected Zone (TMAZ), and the Dynamically Recrystallised Zone (DXZ) or weld nugget. Tensile failure in transverse tensile tests most often occurs within the HAZ or the section between the HAZ and the TMAZ. Due to the change in precipitate morphology, this region is also generally susceptible to corrosion (red lines in Figure 27-25). One way to potentially improve the resulting corrosion properties is through post-weld heat ageing treatments. Another would be to coat the susceptible surface area with another, more resistant, alloy.

(a) Cross section through joint identifying regions of the weld zone.

(b) Outer surface showing exfoliation corrosion (ASTM G-34).

The main concerns that will require additional study and testing of FSW are currently related to corrosion properties, damage tolerance properties (fracture toughness), residual stresses and the long-term stability of the joints. With respect to corrosion maintenance, simply grinding to remove the corrosion will not end

the problem. As mentioned above, it may be possible to improve the corrosion resistance of susceptible areas by re-ageing or coating following corrosion removal, although it would obviously be better and easier to use these options on new structure. On-aircraft repairs will have to be done using riveted aluminum patches, since field repair FSW will not be possible.

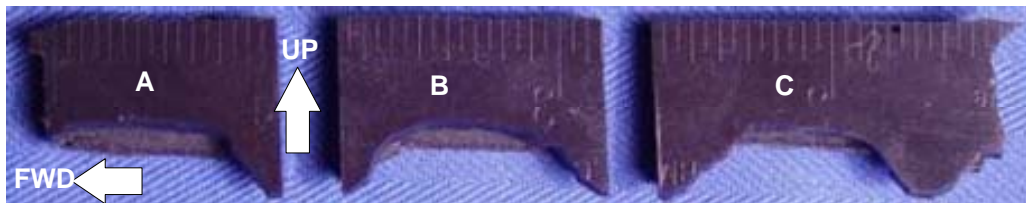
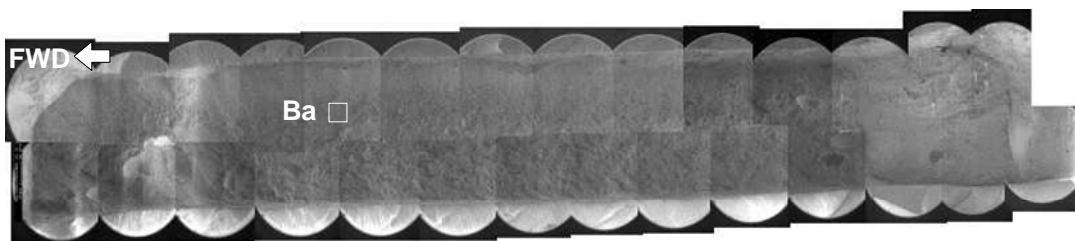
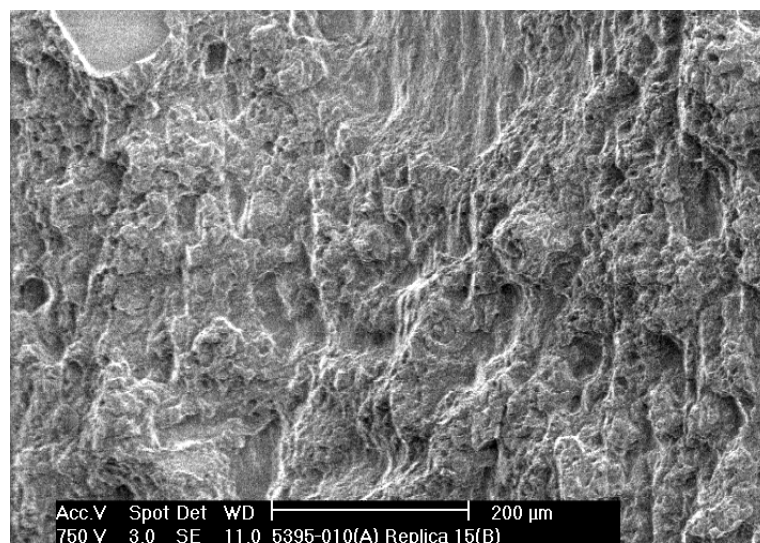
Figure 27-28: Fracture Surface Replica Analysis.

(a) Side view of replica from a fractured skin edge showing fracture surface.

(c) SEM image montage for replica section B. Note selected site Ba.

(d) SEM image of fracture surface at site Ba from failed fuselage skin replica B.

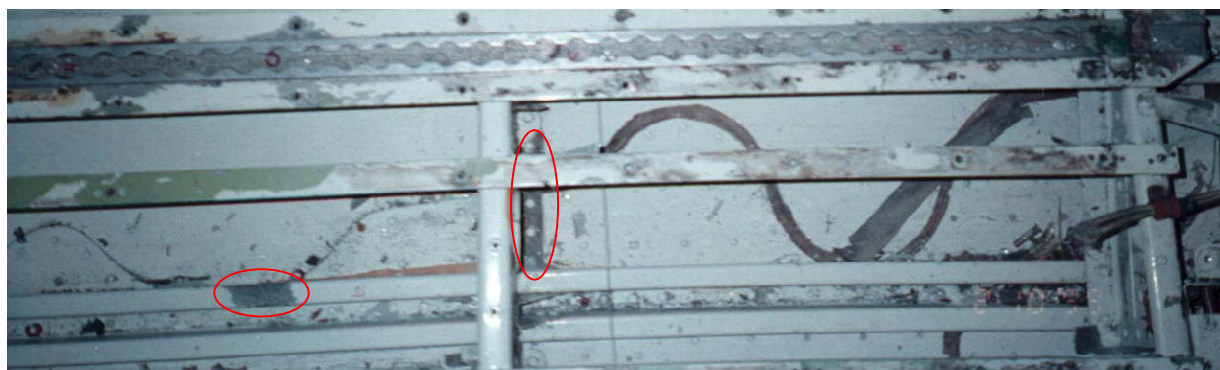
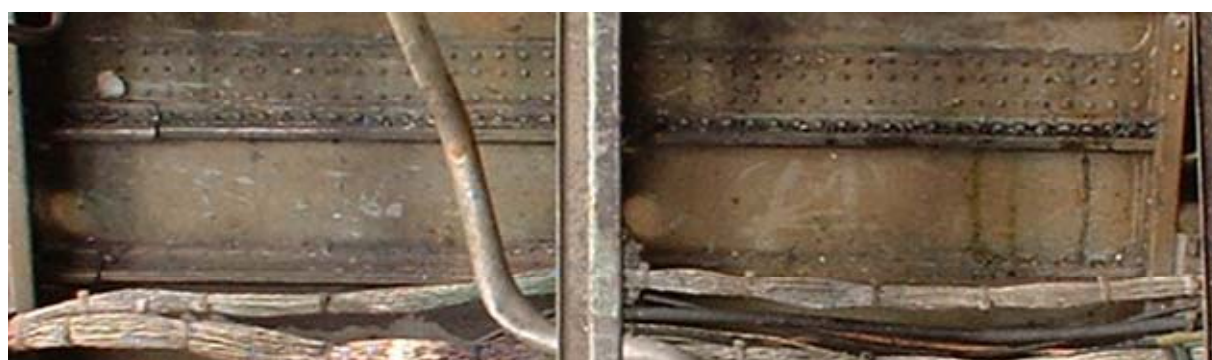
Figure 27-29: Bilge Areas Below Cargo Floor (Floor Panels and Insulation Blankets Removed).

Corrosion Prevention Compounds (CPCs) are applied internally to large areas of ageing aircraft structures. Inspections cannot be completed with these coatings in place because they accumulate dirt and debris and obscure direct viewing of the surfaces. These will often have had multiple applications of CPCs, which bind the dirt and debris in place, and the CPCs become increasingly difficult to remove as they harden with age. Another disadvantage is that the dirt-collecting nature of CPCs discolors white-painted bilges, see Figure 27-29. This discoloration reduces the visibility of corroded areas.

(a) White paint over primer (corrosion circled).

(b) White paint coated with CPC.

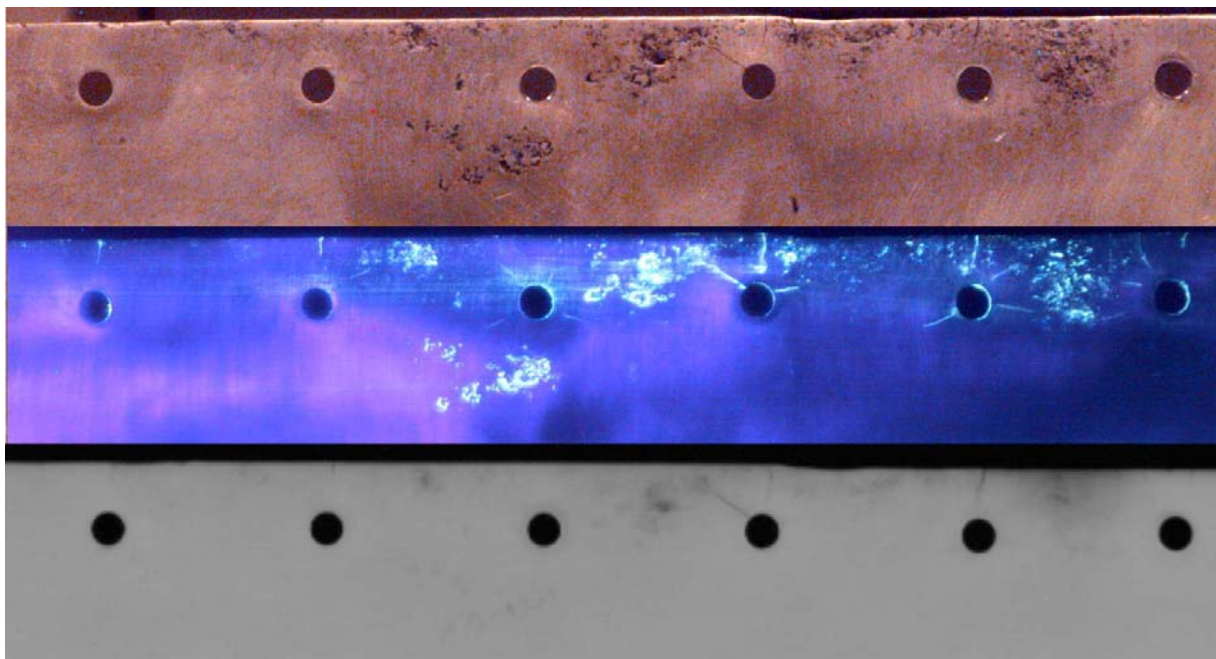
Figure 27-30: Three Views of Inner Surface of a Chemically Cleaned Corroded Skin Exhibiting Pillowing Cracks.

Figure 27-30 is an illustration of crack detection in a chemically cleaned corroded skin that contained pillowing cracks. These cracks were small and non-surface-breaking, i.e., they did not reach the outer surface of the skin. Careful disassembly and cleaning allowed these small cracks to be detected, notably by dye penetrant. Mechanical removal of corrosion products would probably have reduced the number of cracks detected by this technique.

Top: Optical, Middle: Dye penetrant, Bottom: X-ray.

Non-surface-breaking cracks like those illustrated in Figure 27-30 have been predicted by Finite Element Modeling (FEM) of fuselage joint designs. These radiating cracks are caused by tensile forces induced in

the skin faying surfaces when sufficient corrosion products build up between them, causing pillowing. The cracks initiate outside the fastener holes and then grow both towards and away from the holes.

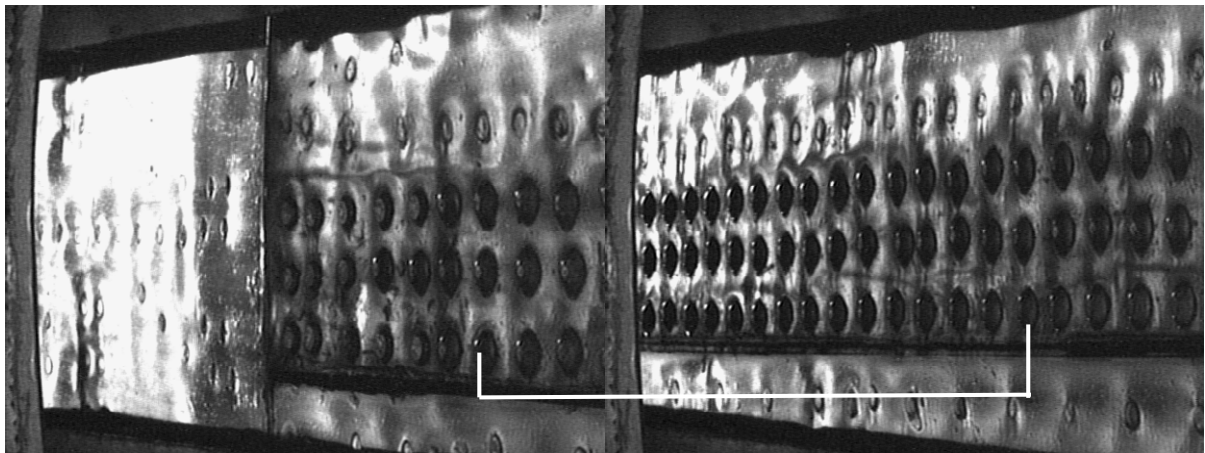
Figure 27-34: DAIS Lap Inspections on the Intact Joint (White Line Shows Specimen in Figure 27-35).

Figure 27-34 is an example of corrosion-induced pillowing from the teardown investigation of a lap joint outer skin. The pillowing was made visible by the D Sight Aircraft Inspection System (DAIS) [10], which enables enhanced visual inspections of intact joints. It was known that the joint had undergone maintenance because of corrosion. This maintenance had included removing the original flush-head rivets and re-installing with protruding-head rivets.

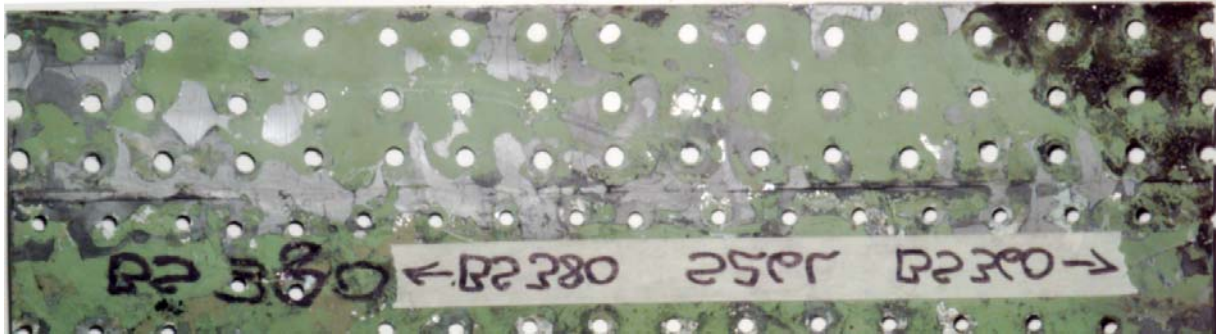
Figure 27-35: Rear Surface of Outer Skin.

The protruding-head rivets made it impossible to inspect the intact joint by eddy current NDI. Consequently the rivets were drilled out to separate the outer and inner skins. Figure 27-35 shows the rear surface of the outer skin. The black and gray areas are the remains of faying surface sealant from the prior maintenance, which had also included applying a primer. Significantly, there was no visual evidence of corrosion at the time of the teardown. This means that the pillowing observed in the DAIS inspection, Figure 27-34, was due to corrosion product accumulation up until the maintenance action, and that the subsequent visible persistence of pillowing was due to permanent deformation of the skin.

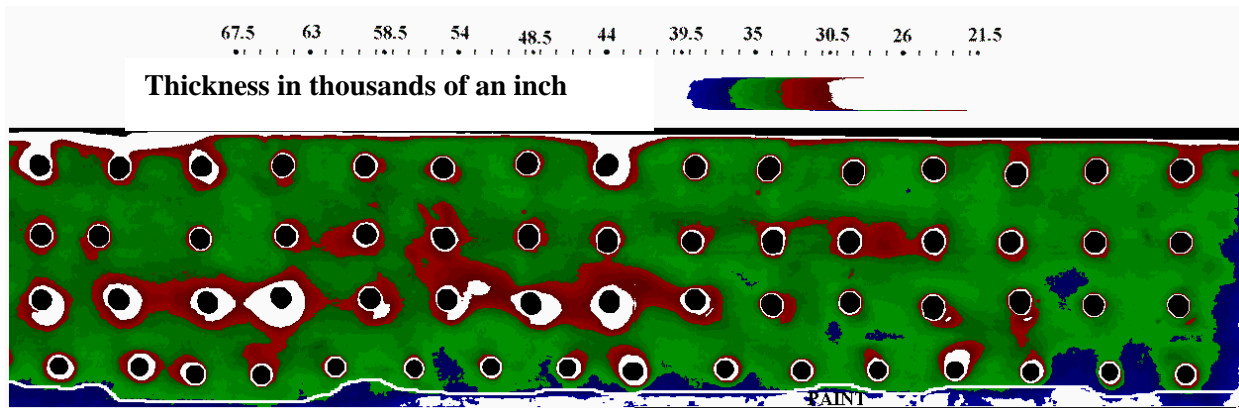
Figure 27-36: X-Ray Thickness Loss Map (Calibration Ramp at Top).

The outer skin inner surface shown in Figure 27-35 was cleaned chemically to remove the sealant and primer. This was followed by X-radiography that included a ramped master calibration tool to enable thickness measurements. The NRC/IAR NDI Analysis™ software was used to obtain the calibration and skin thickness measurements from the digitized image file of the X-ray film, Figure 27-36.

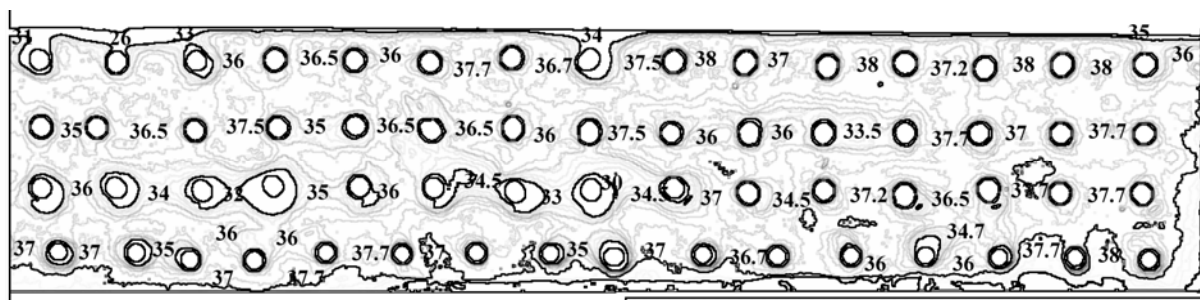
Figure 27-37: Thickness Measurement Map.

Figure 27-37 shows mechanically made thickness measurements taken nominally midway between fastener holes and also where thinning was beyond the lower limit of the X-ray calibration. The maximum thickness was 0.038 inch. The minimum thickness between fastener holes was 0.030 inch [24% loss], and the minimum thickness at the free edge was 0.026 inch [34% loss]. These losses and the pattern of losses, especially around fastener holes, compromised the skin and would have made it more prone to fatigue damage.

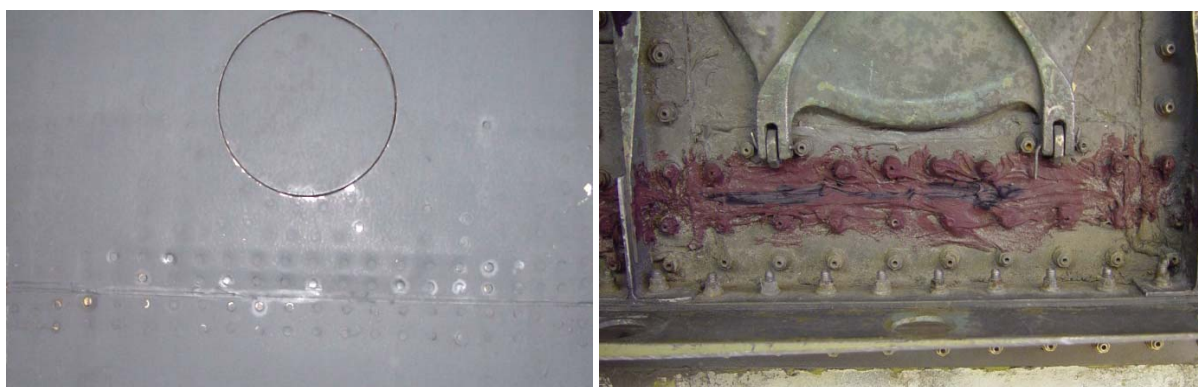
Figure 27-38: A Visual Inspection of the Exterior Surface Indicated Corrosion Pillowing (left) While the Interior Showed Sealant Added (red) Indicating Maintenance for Same (right).

Field inspection of a C-141 airframe located classic visual evidence for corrosion induced pillowing at the joint on Stringer 32 Right, see the left-hand photograph in Figure 27-38. The skin was buckled between the steel fasteners (Hi-Lok® HL19, 100°, Reduced Flush, shear bolts), and some fastener heads were being pulled through the outer skin. Furthermore, this damage was at a known corrosion site, below the sewage access port for the hospitality pallet. The right-hand photograph in Figure 27-38 shows that sealant had been added to the original protection scheme on the inner surface, indicating maintenance for corrosion damage.

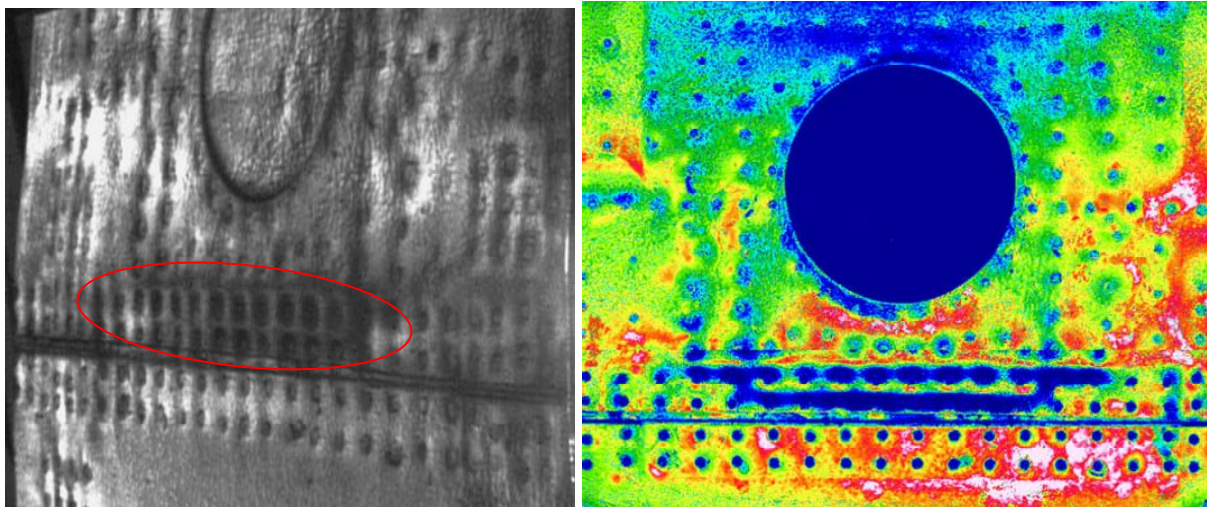
Figure 27-39: Laboratory Inspections Preceding Teardown Both DAIS (left) and UT (right) Indicated Damage in the Upper Skin of the Butt Joint.

Laboratory DAIS and UT inspections gave the results shown in Figure 27-39. The DAIS inspection indicates corrosion-induced pillowing, and the UT inspection apparently indicates corrosion product build-up along two fastener rows below the access port. However, teardown revealed something totally different. Figure 27-40 shows that a shim had been placed along one bolt row, presumably during maintenance. Tightening of the steel bolts caused the outer skin to buckle, and where it was unsupported by the shim the fastener heads tended to be pulled through the skin. The resulting incomplete clamp-up confused the UT inspection, since air gaps were interpreted as corrosion build-up.

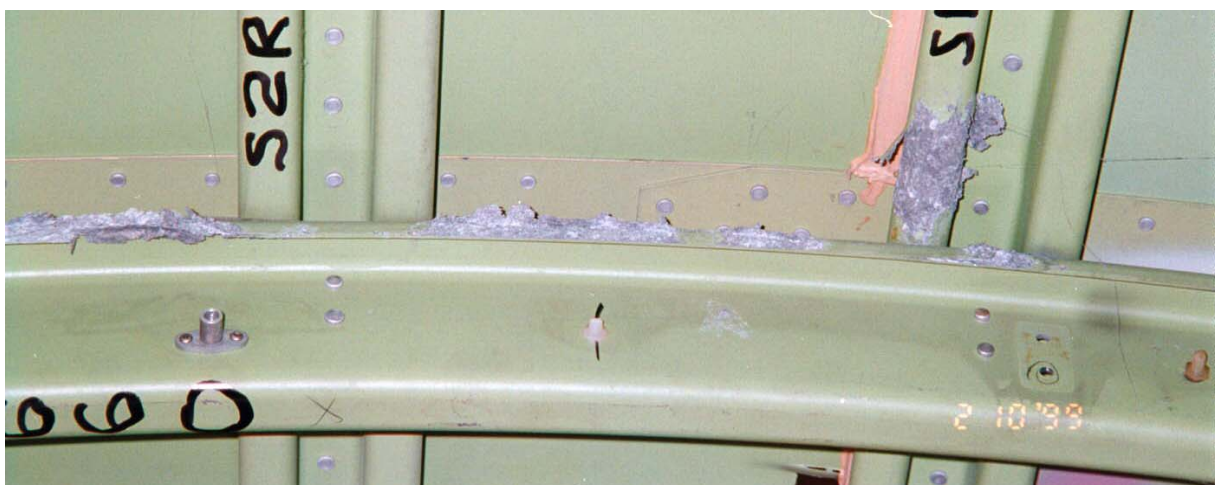
Figure 27-43: Stringer and Frame Corrosion in the Crown of a Stored Fuselage Due to Moisture Remaining in Insulation Blankets (Removed).

Note from Figure 27-42 that these WFU aircraft are parked in desert environments. Actually, deserts are *not* the best places to store aircraft that have been in service. It has been assumed that the arid climate minimizes corrosion activity. This may be true for the exterior surfaces, but experience has shown that the closed-off internal environments still support corrosion processes, and the high daytime temperatures may well accelerate them. Consequently, desert storage areas have proven to be productive sources of examples of service and post-service corrosion, Figure 27-43 and Figure 27-44.
